Coastal Ice Rubbles in Isfjorden (Spitsbergen)

Nataliya Marchenko
The University Centre in Svalbard, Longyearbyen, Norway

ABSTRACT

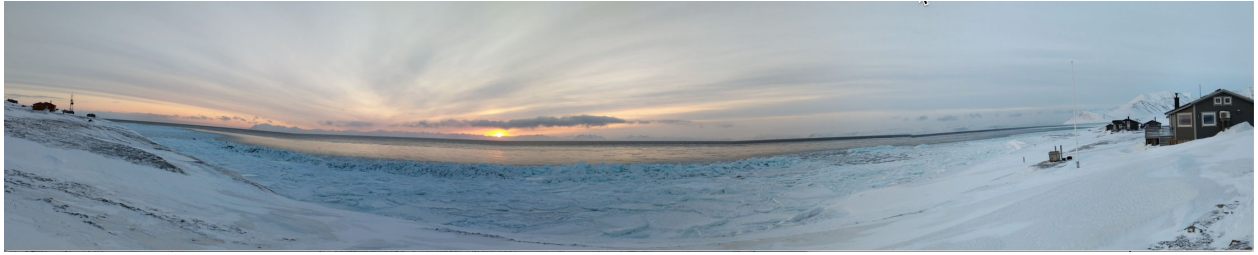
Figure 4. Panorama of Ice Rubble on the 4 of April 2020.

The Ice Rubble was discovered on 4th of April 2020 near Longyearbyen town, along the south-east coast of Isfjorden. The location is marked in Figures 1 green arrows, in Figures 2 and 3 by red arrows. It is visible that land fast ice is shown in ice maps in this place (Figure 3). Local citizens living in huts nearby said that they did not remember such ice piles in this place for the last ten years. They were surprised and paid a lot of attention to such seldom phenomenon. The author does not remember something similar since 2006, being on Svalbard. Such phenomenon was not observed in 2021-2023. The Ice Rubble appeared after a storm that lasted for several days and left also piles of seaweed onshore 3-4 m above the water level, revealing the scale of waves. The meteorological station of Longyearbyen airport reported north-west wind 10 m/s with gust up to 15-20 m/s (see (NMO, 2023)). Actually, the ice piles were observed along the all coast at the exit (mouth) of Adventfjorden, where the fast ice marked on ice map. But in the pointed place the ice strip was much wider, ice blocks bigger and piles higher. This “main ice rubble” had size 250x500m with the sail height of ice blocks up to 6 m above water level. Ice floes constructing the rubble were up to 0.9 m thick (Figure 4-8).

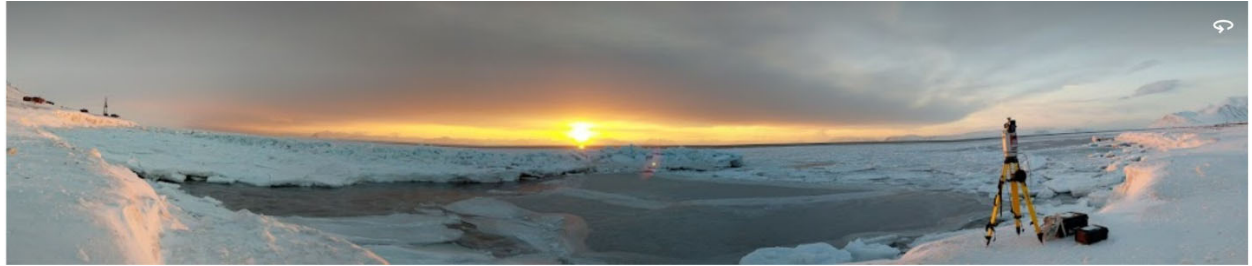
Figure 5. Panorama of Ice Rubble on the 9 of April 2020 features laser scanning procedure.

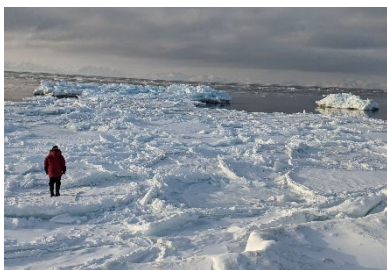
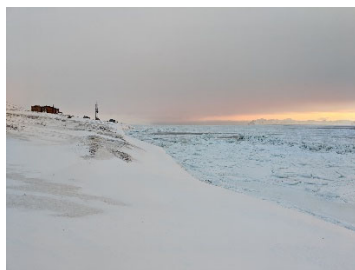
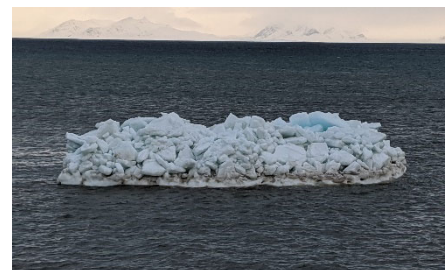
Figure 6. Appearance of Ice Rubble on 5-14 of April 2020.

On the 11th of April the wind changed to the eastern and together with high tides it contributed to the rubble destruction and carrying away the ice blocks composed the rubble. On the 14th of April only one stamukha and two floating ice floes presented the disappearing rubble (Figure 6).

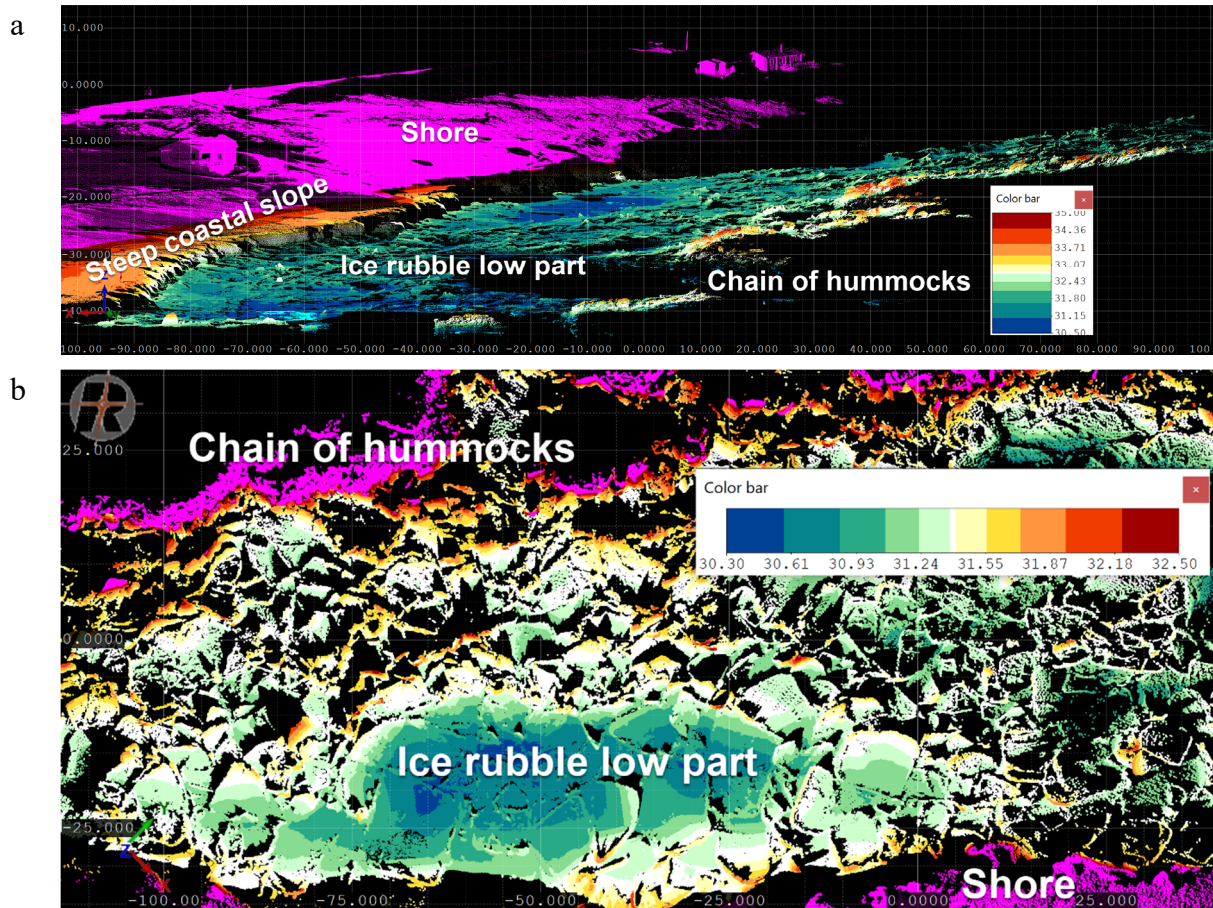
Figure 7. Laser Scanning of Ice Rubble on 5 of April 2020 at 16.30. Water level is 40 cm. a. 3D point cloud. View from the rubble to the shore. b. 3D point cloud. View from above. Color bar is in the Scanner project coordinate system. Pink color is for elevation above the scale.

Laser scanning with Riegl VZ 1000 was performed from 2 points on the hill to obtain the 3D point cloud (Figure 7 and 8) on the 5th and 9th of April. Data is published in the form of ASCII and las. files and can be found in Norwegian Polar Institute data Centre (Marchenko, 2023a, Marchenko, 2023b).

The tidal variations significantly influence sea ice dynamic in the coastal line. In the period from 4th to 9th April the difference between low and high tide increased from 67 cm (59-126 cm) to 200 cm (-16-184 cm), creating considerable ice dynamics. All ice blocks and hummocks were lying on the bottom in low tide (Scan on 9th of April – Figure 8) and the difference in elevation between levelled internal part and ridged boundaries exceeded 6 m. In high tide, only the most significant ice blocks and hummocks were grounded. The flat and small ice floes floated and elevation difference was less (4.5 m during the scan on the 5th of

A chain of high hummocks bordered the heap of ice floes from the outside and rather abruptly broke off into the water. And the space between the hummock and the shore was filled with ice floes the size of 2-15 m – bigger and flatter close to the shore and smaller and more ridged close to the boundary. See ice floe composition on 3D point cloud (Figure 7b)

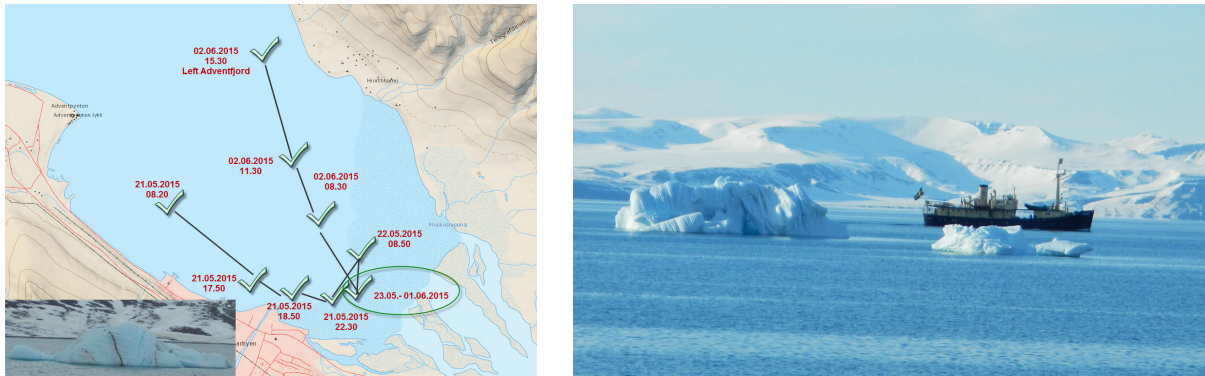
a. Iceberg and its movement in Adventfjorden in May 2015

b. Big iceberg with ship on background in Isfjorden in 25 May 2015

Figure 9. Icebergs in Isfjorden in May 2015

presented in Figure 9. Laser scanning of one of the large icebergs grounded near a Coal port showed horizontal size 20x35 m and an elevation above the water of 7 m.

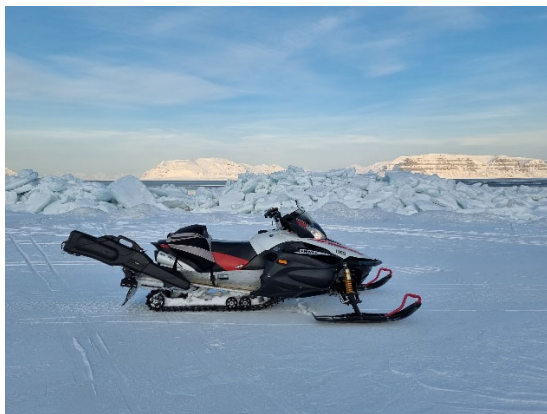
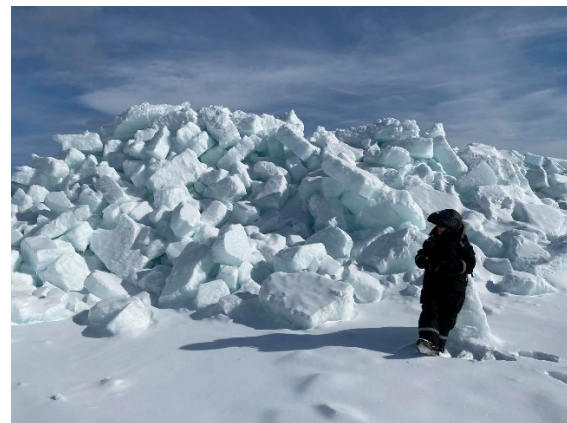
Near Diabasoden, 13 March 2022
(78°21' 21"N 16°11'20" E)

Near Kapp Schollin, 1 May 2022
(77°46'01"N 14°41'32" E)

Figure 10. Shore rubble fields in Spring 2022. Photo courtesy of Dina Brode-Roger.

In spring 2022 several large shore rubble fields were observed in Western Spitsbergen in and near Isfjorden. The piles of ice block stretched several tenth meters in length (60 m near Diabasoden and 170 m near Kapp Schollin – Figure 10a and 10b) along the sea line on the coast and had high more than 3 m. Ice blocks with different shape looked like the pieces of flat floes and had thickness 40 cm. There are two examples in Figure 10 with scooter and scooter driver for the scale. The process of formation was shore ice ride up rather seldom in Western Spitsbergen.
